SOME ENGINEERING PROPERTIES OF UDZUNGWA SCARP SOIL

Gerald Roosevelt Maregesi
Advanced Engineering Solutions LTD,
Dar Es Salaam - Tanzania
Email: Gerald.maregesi@aesl.co.tz

SYNOPSIS

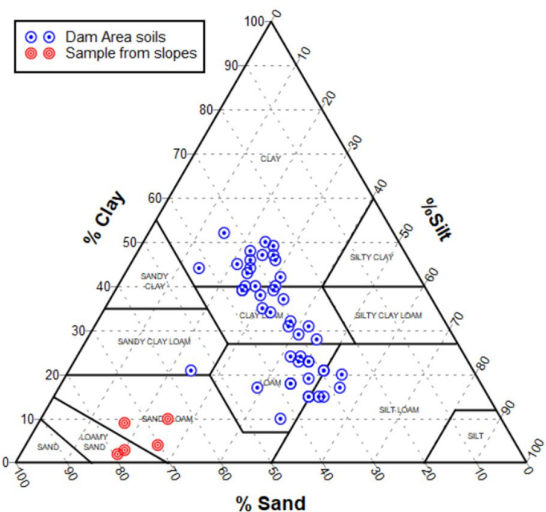
Figure 3: proportional of clay, silt, and sand

Five soil samples were taken from the area affected by severe erosion and landslides and tested in the laboratory. The grading test results indicate that the soil has low clay content (typically less than 10%). The grain size distributions curves of soil sampled from the area affected by erosion are shown in Figure 8. The grading properties of these soils, expressed in terms of the coefficient of uniformity (C_u) and the coefficient of curvature (C_c), are shown in Table 1. Three samples out of five samples meet the requirements of the Unified Soil Classification System of well-graded soil, where a well-graded sandy soil should have both $C_u > 6$ and C_c between 1 and 3. The grading properties indicate that these soils can be well-graded or poorly graded silty sand with a very low percentage of clay (Figures 3 and 8) suggesting that the soil becomes more resistant to erosion as clay content increases.

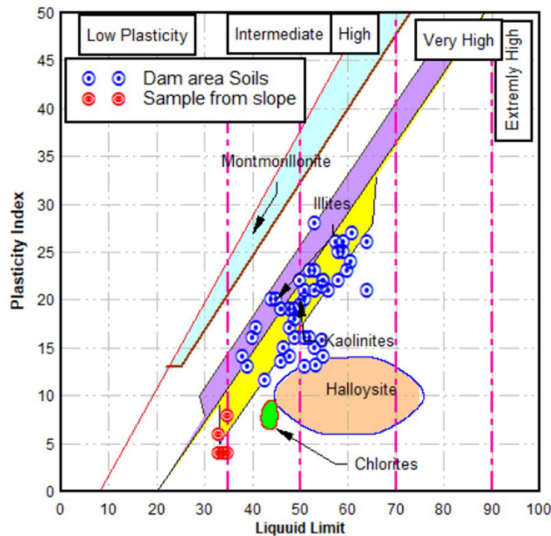
Figure 4: the position of Udzungwa soil on Casagrande A-Line plasticity chart

The position of soil on Casagrande A-Line chart is given in Figure 4. From the plasticity chart,

it can be seen that the main clay mineral within the soil matrix is likely to be kaolinite since the majority of the soil plots within the band of kaolinite clay with few soil samples plotting within the band of illite clay.

2. The high void ratio in the soil is an indication that the soil possesses a very low inter-granular/effective pressure and low shear strength. The position of the soil on the A-Line plasticity chart is shown in Figure 4 from which it can be seen that the soil is of low plasticity, and based on the A-line classification chart, the soil can be classified as silty sand of low plasticity.

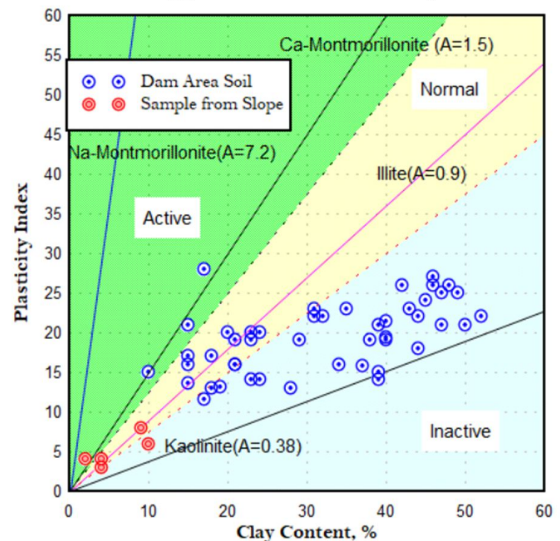
Figure 5: Position of soil on Skempton activity chart

plotting within the band of normal clay. Four out of forty-seven tested soil samples plotted marginally within the band of active clay. For the soil sampled from locations that exhibited slope failure, the activity of soil was found to be in the range of 0.6-2.0. The position of soil on Skempton Activity chart is given in Figure 5, from which it can be deduced that the principal clay mineral in order of relative abundance is likely to be Kaolinite and Illite echoing the classification of the clay minerals done based on the position of soil on the plasticity chart which also suggested the same clay minerals.

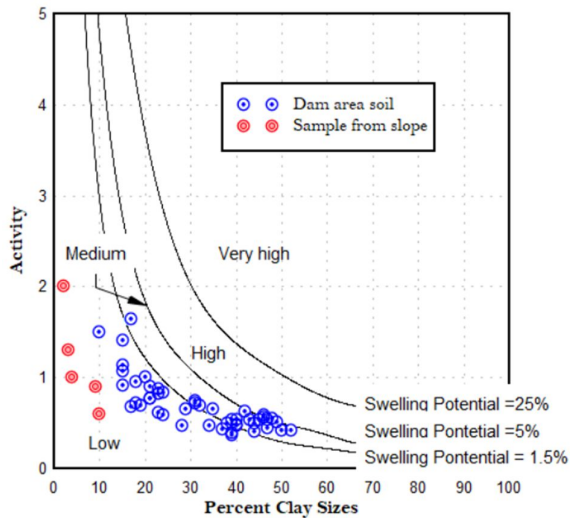
Figure 6: classification chart for swelling potential [14]

Figure 6 and 7 shows the volume change potential of the Udzungwa scarp soil using Seed et al [14] and Van Der Merwe chart [6]. The data indicates that the Udzungwa scarp soil has low expansive potential as the majority of the soil samples falls in the low to medium expansivity class as assessed using both methods of Seed *et al.* and Van de Merwe. In Seed *et al.* chart, the soil is having swelling potential (S) of between 1.5% (low) and 5% (medium). The majority of the soil sample falls within the band of low expansivity potential, i.e. swelling potential of less than 1.5%.

Based on Figures 6 and 7, it can be seen that the soil can be classified as low to a medium swelling potential, which also suggests that soil available within the Udzungwa scarp is not containing an expansive clay mineral i.e. montmorillonite. The plot of soil on the plasticity chart suggests the same, i.e. the possible clay minerals within the soil is kaolinite and illite. For the soil sampled from the areas which exhibited slope failure, all five soil samples showed to have low expansivity potential.

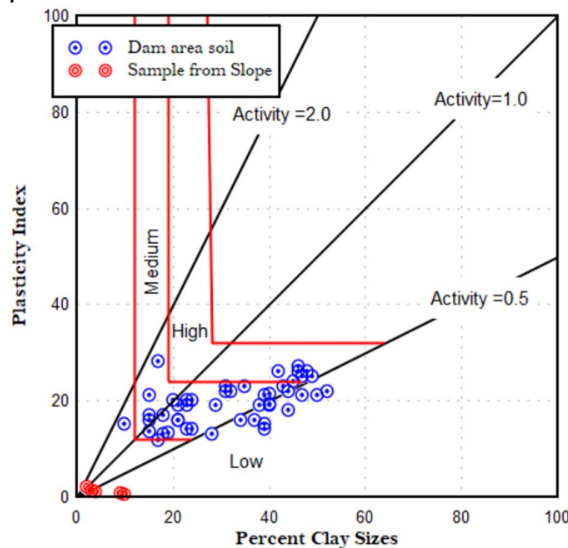
Figure 7: classification chart for swelling potential [23]

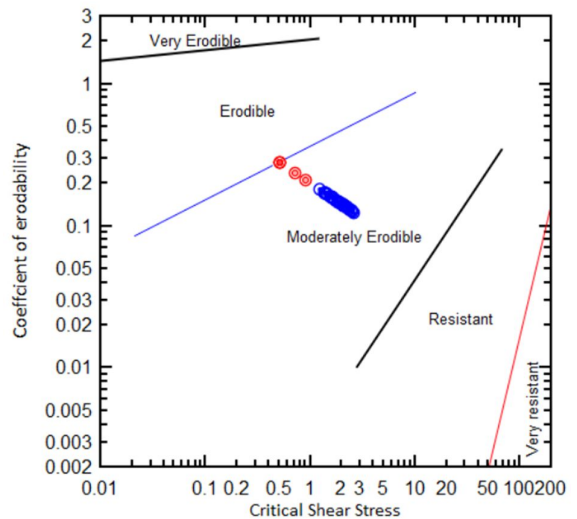
Figure 9: classification of erodability of Udzungwa scarp soil [18,19]

increase, requiring higher shear stresses to mobilize the grain, which results in increased resistance to erosion. The density of the soil also is known for improving the soil erodibility. But as it can be seen in Table 2, the soil available within the project area, which exhibited slope failure is having low dry in-situ density signifying that the soil can be easily eroded by fast-moving water after a rainfall. Based on erodibility classification of soil developed by Hanson [18,19], it can be seen that the soil available within the scarp falls within the band of moderately erodible soil, while the soil sampled from the location which exhibited slope failure is showing a high level of erodibility despite of the fact that all soil samples are falling within the same band of moderately erodible soil.

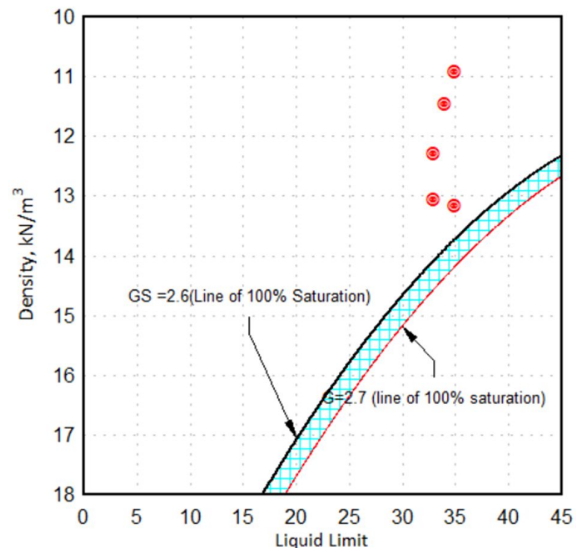
Figure 10: classification of collapse potential [20]

In order to assess the collapsible potential of the soil, the soil was evaluated using methods developed by Holtz et al. [1961][20] and Moghadam [2006] [21], which the dry density of the soil is related to the liquid limit and dry density is related to percentage passing 0.075 mm sieve. The soil, when plotted on these charts, falls within the band of collapsible soil, suggesting that the soil available within the scarp is collapsible soil.

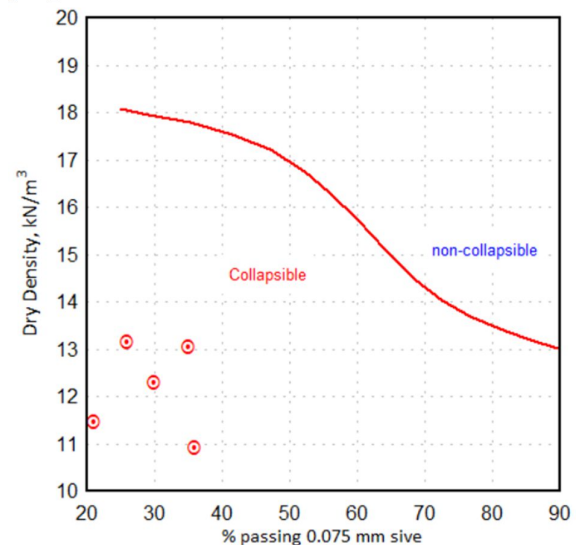
Figure 11: classification of collapse potential [21]
